EXPERIMENTAL INVESTIGATIONS OF METAL WIRE BASED EMI TECHNIQUE FOR STEEL STRUCTURES

Abstract: Infrastructure construction is the second largest economic activity in India after agriculture and it is growing rapidly. Structural Health Monitoring (SHM) aims to provide new solutions for easy and swift inspection of engineered structures. Electromechanical impedance (EMI) technique is a relatively new useful and convenient technique in the area of SHM. Though this technique shows promising results in the area of SHM, the main disadvantage of this technique is the brittleness of the piezo-electric (PZT) material. To overcome this problem, a new variant has recently emerged wherein a metal wire is coupled with the PZT patch and then attached with the host structure. This paper primarily focuses on evaluating the metal wire based EMI technique for damage assessment of 2D structure. Test results show that the technique can effectively identify and locate damage on a 2D structure.

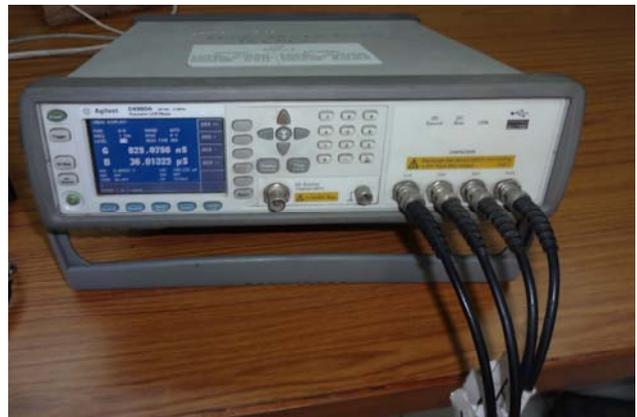
2D structure^[4]. Electromechanical admittance can be decomposed and analysed to extract the impedance parameters of the structure. In this process, the PZT patch will act as an impedance transducer, which enables the structural identification for SHM. The PZT patch acts as actuator as well as sensor. The main idea of EMI technique is that the presence of damage in the host structure will affect the mechanical impedance and then the admittance of the PZT patch, will directly measured by an LCR meter which is shown in the Figure 1.

Figure1 Electrical impedance analyzer (LCR meter Agilent E4980)

The LCR meter imposes an alternate voltage signal to the bonded with PZT patch over the specified frequency and the changes in the admittance signature gives the indication of structural damage which can be easily accessed for the identification of damage assessment. This admittance signature is a function of stiffness, mass and damping behaviour of the assessed structure.

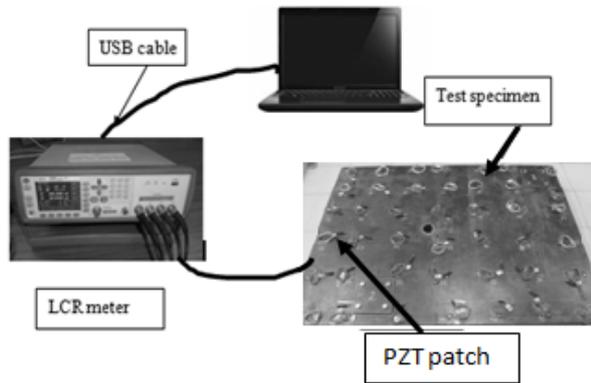
The schematic set up of the experimental set up is shown in the Figure 1 where the Agilent E4980A 20Hz-2MHz precision LCR meter is connected to a laptop and a specimen through USB cable. The values of conductance (G) and

susceptance (B) were obtained by connecting in frequency range 100 to 150 kHz through the Agilent VEE Pro 9.0^[5].

Figure 2 General Schematic set up of the total system

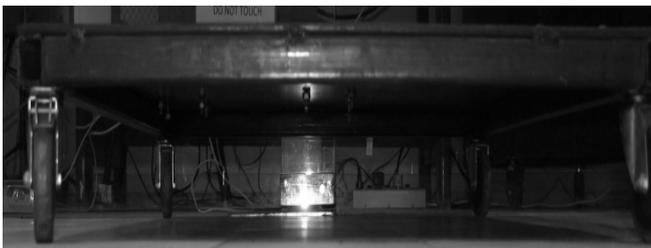
The steel plate shown in Figure 3 has dimension of 1270X970 mm² and is 8 mm in thickness. The chemical composition of the steel plate includes carbon of 0.23 %, manganese of 1.5 %, sulphur 0.045%, phosphorus of 0.045% and silicon of 0.40% as per IS-2062, 2006. The steel plate was supported on box section pipe of cross section 38X38 mm² and 3 mm thickness and the pipe was welded along the perimeter of the steel plate.

Figure 3(a) Side view of the Steel Plate of 1270X970 mm²

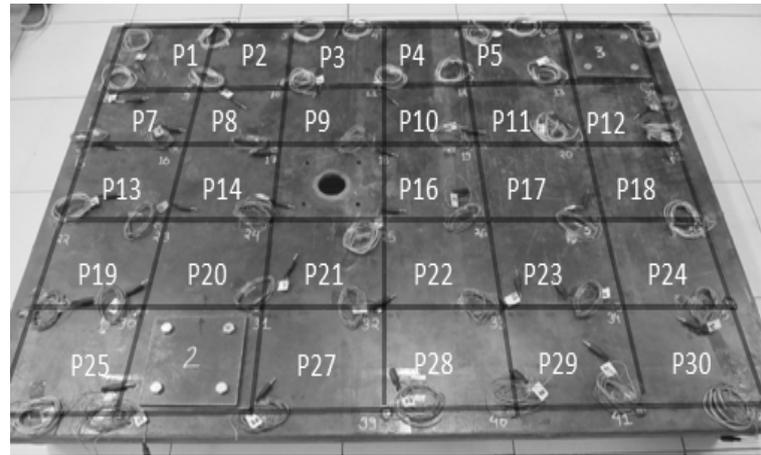
Figure 3(b) Front view of the Steel Plate of 1270X970 mm²

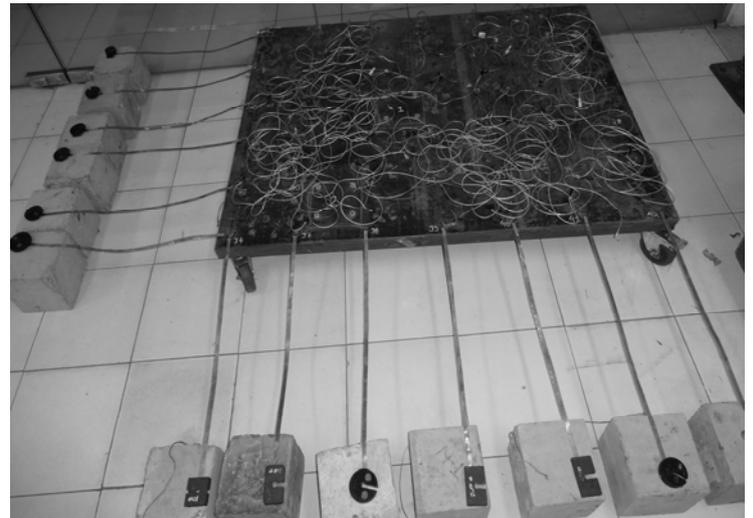
After the fabrication of the steel plate, metal wires of length 50.8 has been attached with the plate at two sides of it, and then PZT patches were attached on the plate and the metal wire with two part Araldite epoxy adhesive. The whole Plate with metal wire is shown in Figure 4.

Figure 4 Whole Steel plate with metal wire set up

The plate has been divided in panels and on each panel the PZT's patches were attached, and for the metal wire the PZT's patches were attached at one end and the metal wire is attached along other end to the plate. The main advantage is this technique is we can remotely control the structure with the help of this metal wire technique. For the conventional method the total PZT numbers are 42, and we have to take ($n \times n$) measurement which will take a long period. But with the help of the proposed technique we can easily detect the damage by $2n$ sensors where n is the number of the sensor grids (here 7). So the number of readings also get decreased and it is time saving too and mainly we can easily further use the metal wire along with the PZT's for other structures.

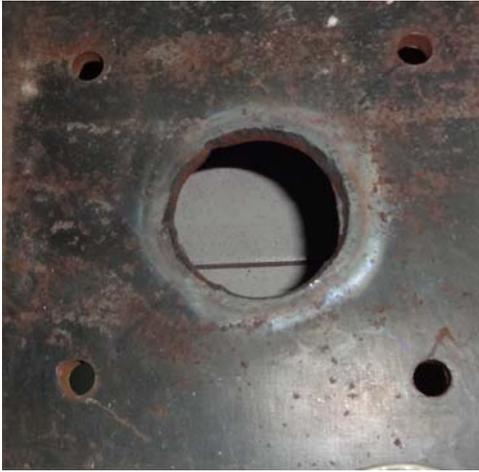
In this experimental study, pre-emptive damage detection has been done in both the plate and metal wire is accomplished by using PZT patches of 10x10 mm² and LCR meter only ^[7]. A single hole of diameter 5cm was made at the 15th panel of the plate which is shown in Figure 5. A cover plate as shown in the Figure 6 was placed over the damage, as a retrofitting measure and four 10mm diameter bolts were tightened at 30 N-m torque to get a repaired condition.

Figure 5 Damage location created at the 15th panel of the plate

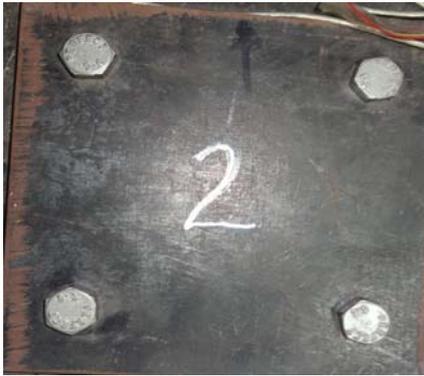
Figure 6 (a) Retrofitting plate with four bolts of 10mm diameter,

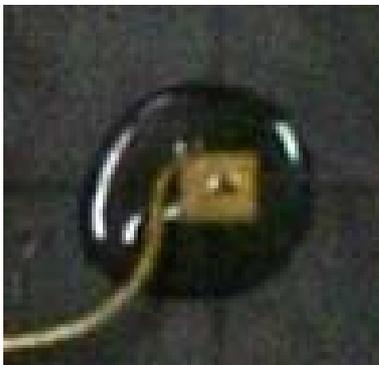
Figure 6 (b) PZT patch attached on the steel plate

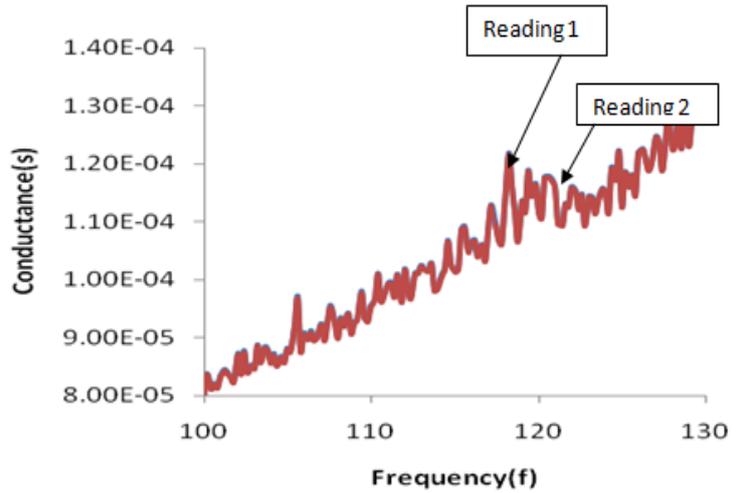
For the both proposed metal wire technique and conventional EMI technique, the base line of the conductance signature was acquired from the PZT patches, which has been shown in Figure 7 for both damaged and undamaged condition with the help of VEE Pro. 9.0. The repeatability of the signature is excellent as shown in the figure 7(a) and 7 (b). Damaged condition is being created by removing the repairing cover plate from the hole and then RMSD values from equation 1 is being calculated for each PZT patch.

Figure 7(a) Repeatability test signature for 6th PZT patch for conventional technique

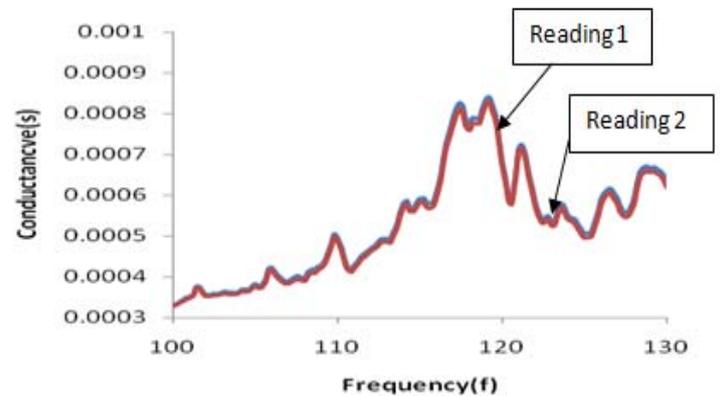
Figure 7(b) Repeatability signature for 6th PZT patch for metal wire technique

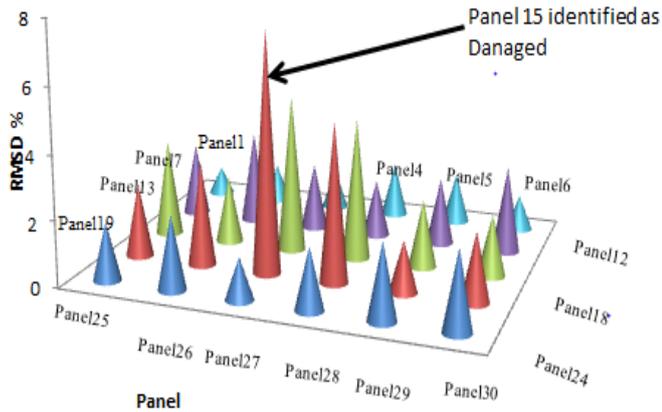
The RMSD values for conductance signature for each patch for steel plate have been calculated from the equation 1 and 2D bar graph has been plotted for steel plate and Figure 6 (a) shows the RMSD plot for steel plate using conventional approach. The same procedure has been repeated for metal wire also and the RMSD plot for the metal wire is shown in the approach

Figure 8 RMSD of signature at 30 panels acquired for steel plate

From the Plot we can easily see that for both the cases the damage has been detected for the panel no 15 where actually damage has been created. After comparing the two RMSD plots, both the methods are giving correct result. But for the metal wire technique, we do not need to calculate 42 panels, we can easily detect the damage from 14 sensors.

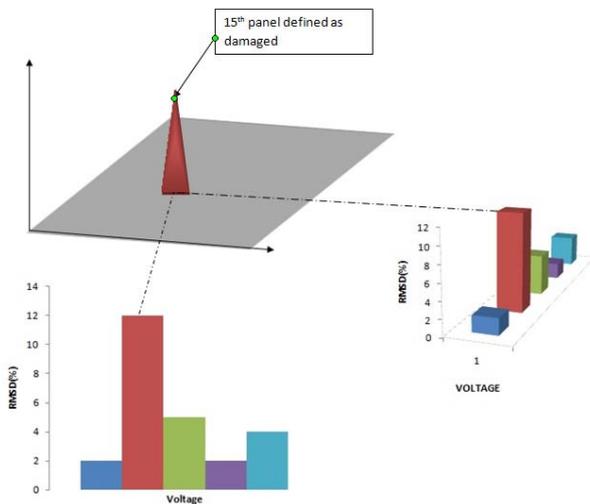
Figure 9 RMSD of signature plot for proposed metal wire technique
